19 November 2020

### MULTICELL CLUSTER STORM CAUSES HAVOC IN MTHATHA ON 17 NOVEMBER 2020

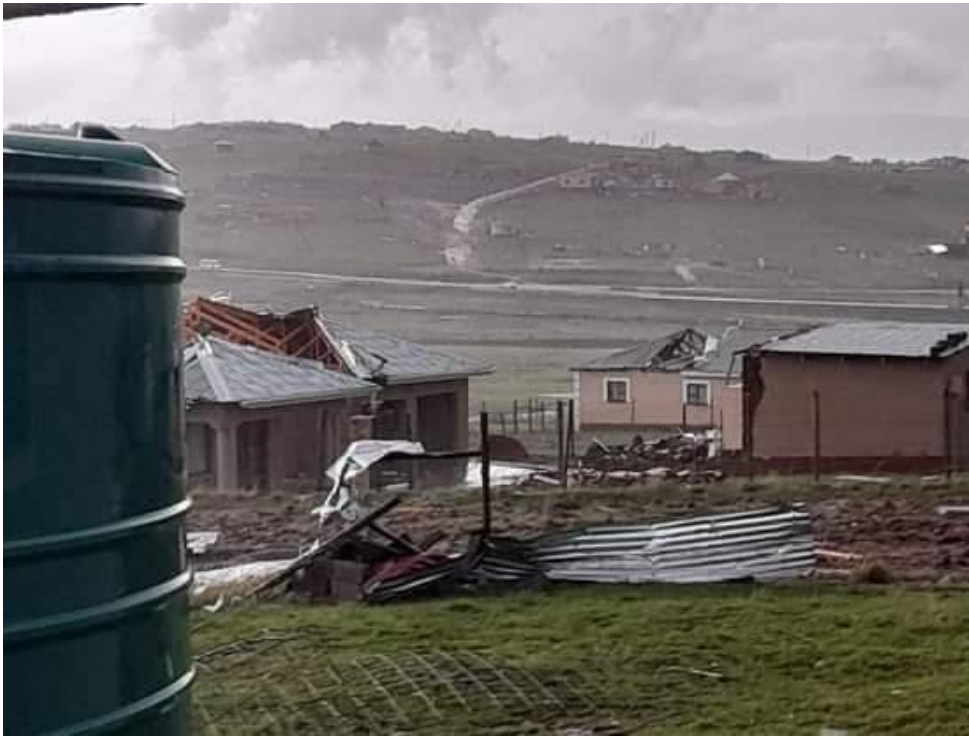
The storm is rated as an EF2 to EF3 tornado because of the supporting damage: torn-off roofing sheets, peeling of roofs at the corners over a relatively large area as well as photographic evidence of a vehicle which appears to have been tossed into the air by the strong winds.

In the image below, roof sheeting has been torn back partially on the two houses, but in opposing directions. It is evident that the clockwise spin associated with the tornadic vortex tube resulted in the damage of the property.

Figure 3: Damage caused

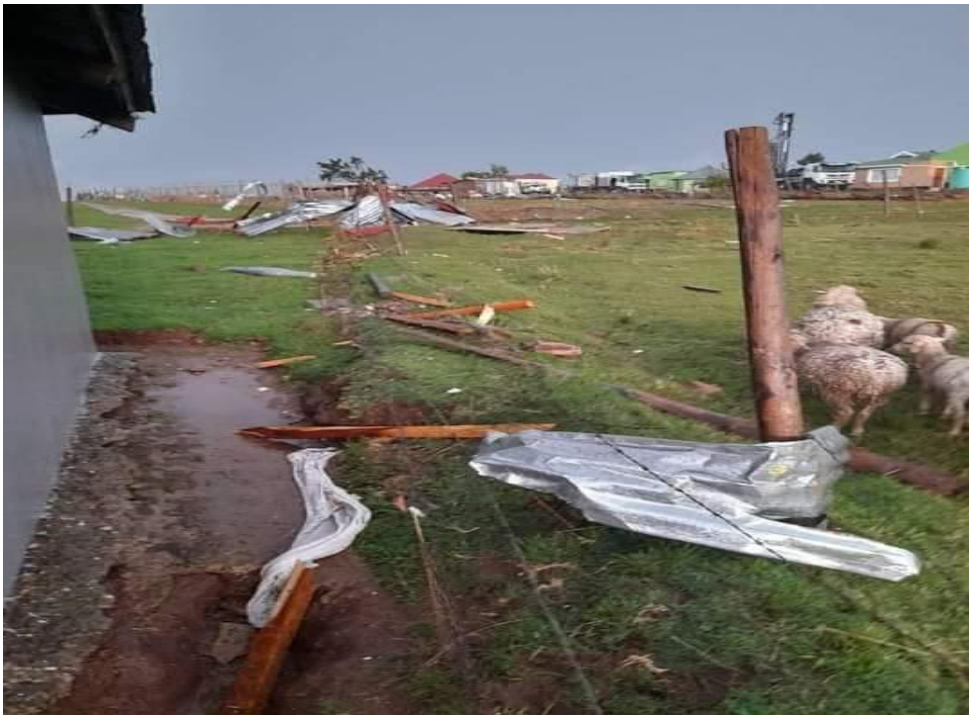
Figure 4: The grass and debris in the image above are matted into a fence, pushed over, broken and eventually flat on the ground, which is a common feature of damage caused by a tornado.

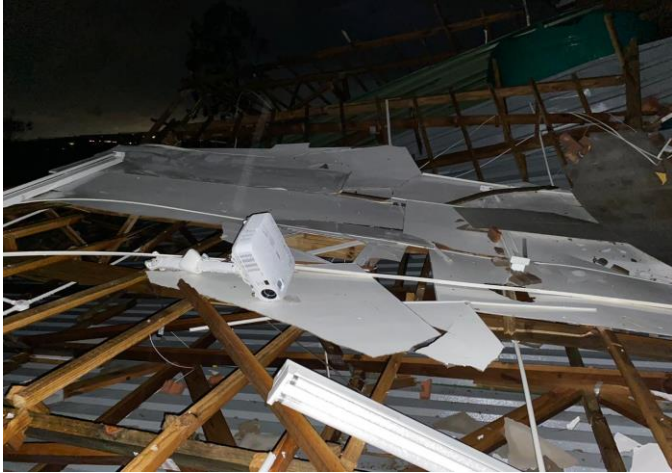
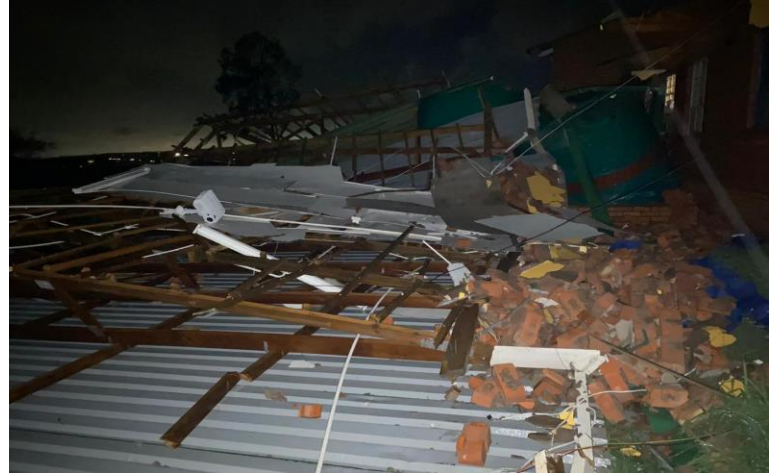
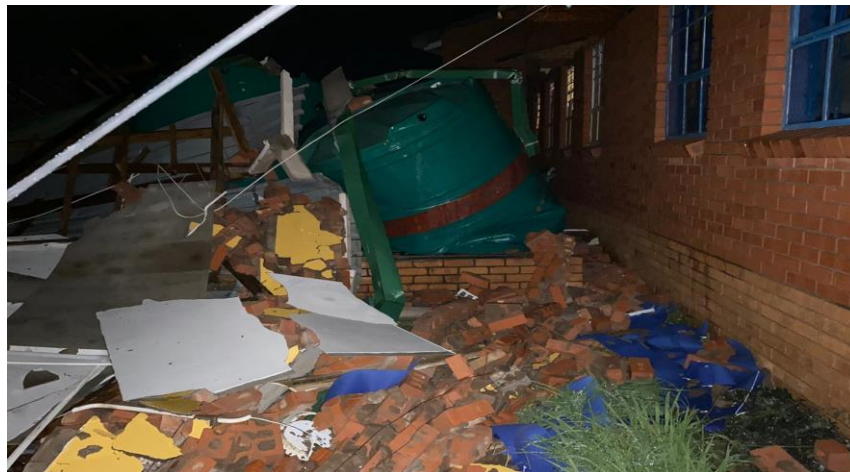
Figure 5: Collapse of a well-built wall

In the images above, considering that the wall was well built and now it has also collapsed, it may be deduced that some areas of EF3 scale may be evident due to the tornado's impact. However sometimes the roof beams pull down some parts of brickwork, rather than solely the wind force on the brick wall.

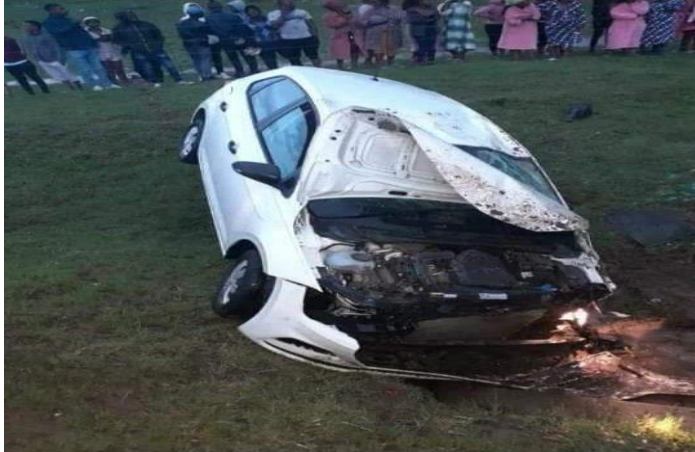
Figure 6: Damage to a car
