Confirmation of Velddrif waterspout – 13 August 2022

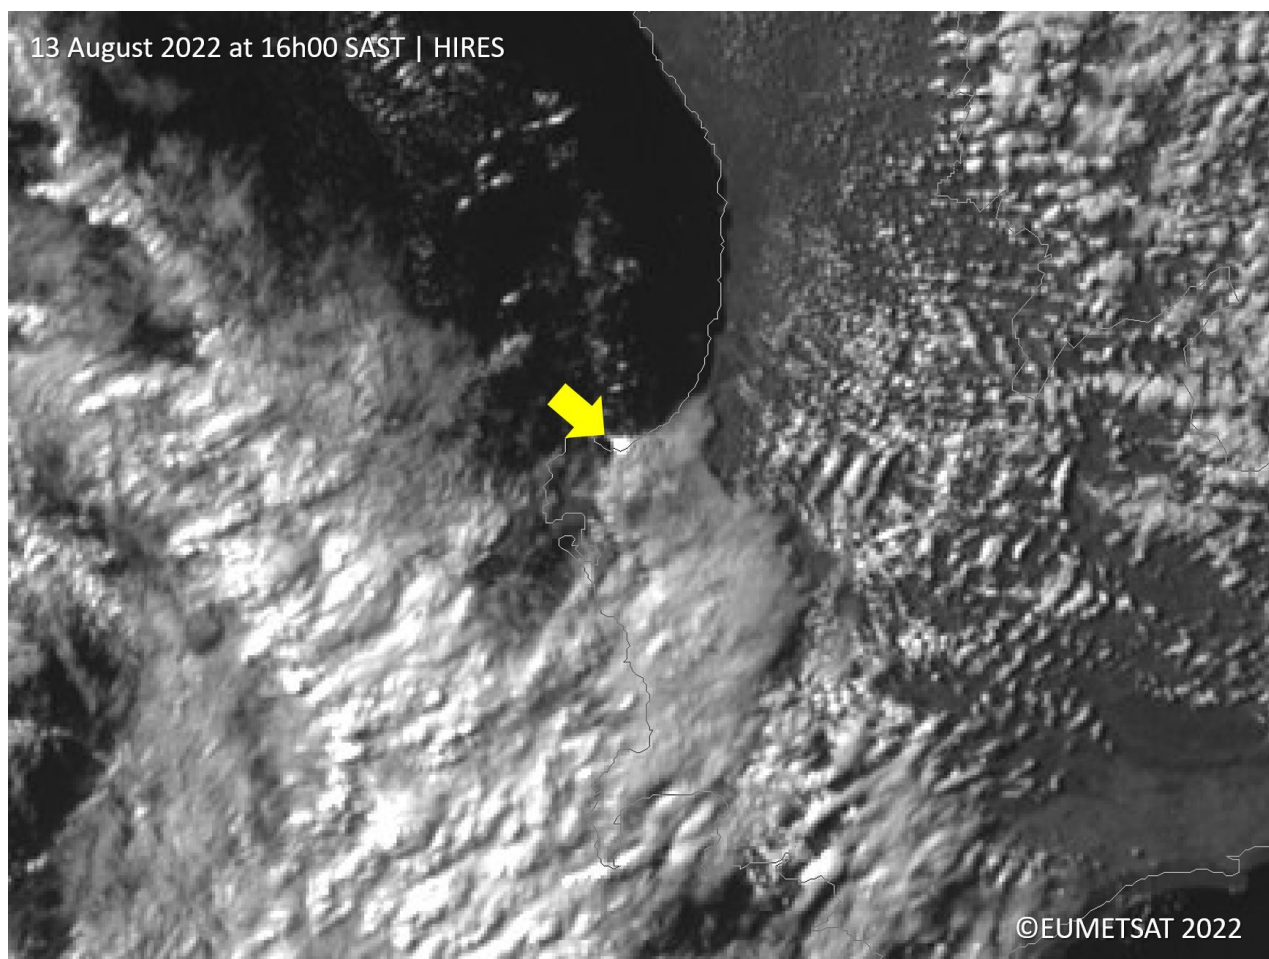
Figure 1: HIRES satellite image valid for 13 August 2022 at 16h00 SAST (14h00Z) (source: EUMETSAT).

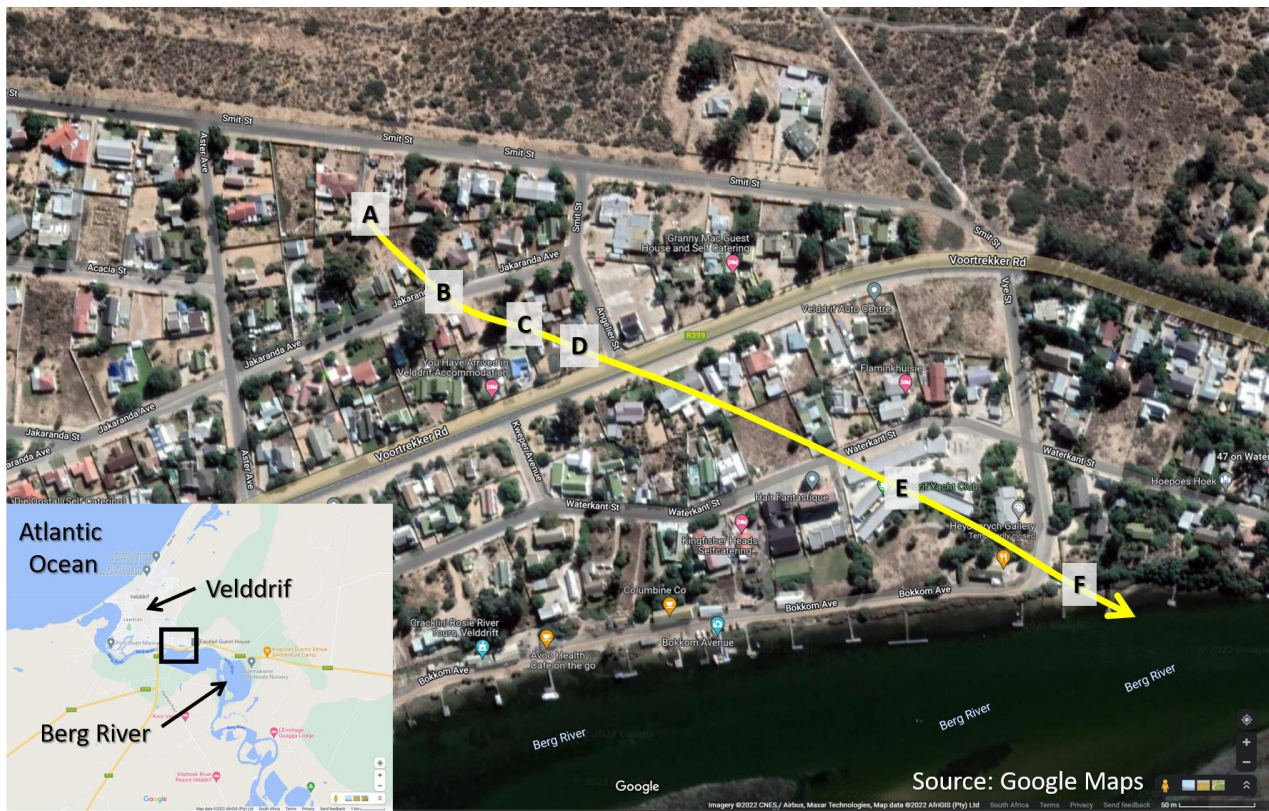
The track of the waterspout as seen in figure 2, started at point A and ended at point F. It was determined that the length was roughly 565 m as calculated from Google Maps, and the width was estimated to be between 20 and 26 m. One of the community members whose property was affected recalled that the roof sheeting was blown to approximately 800 m from their house. The duration of the waterspout cannot be determined thus far, but it seems like it was a fast-moving system by referring to the video evidence, satellite images and personal accounts.

Figure 2: The track of the waterspout from A to F (source: Google Maps).

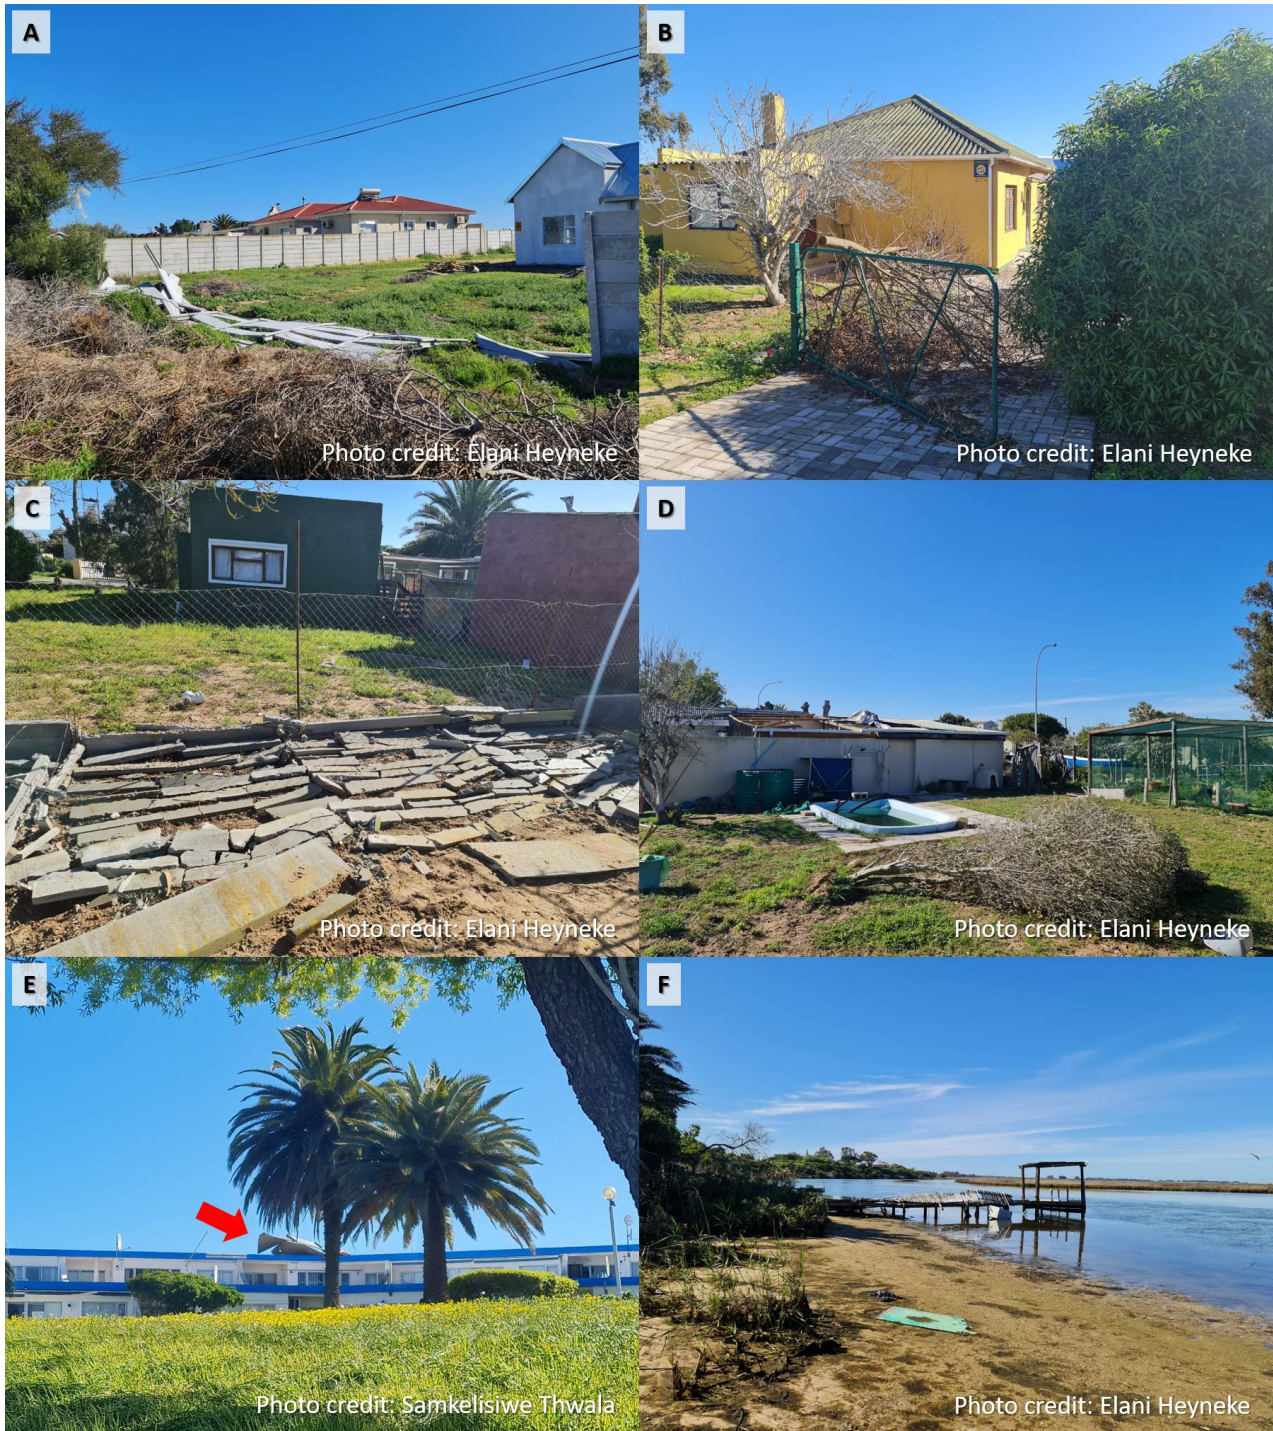
The track of the waterspout was determined by assessing where it was first observed, where it touched down and the last sighting. Unfortunately, only the last part of the track could be assessed in detail, since it is highly likely that the waterspout originated over the Berg River. Therefore, there is a strong possibility that the track could have been longer. The damage and evidence where the waterspout went through can be seen in figure 3. Where, A is a boundary wall that was blown over; B is a large branch that was taken by the wind from the back of the property and dumped on the fence; C is the boundary wall of the second property (across the street) that was blown over; D is an olive tree that was uprooted and a roof blown away; E is the roof of an apartment building that was damaged; F is a green roof sheeting of the second property (picture D) that was dumped on the shore of the Berg River as well as a damaged jetty.

Figure 3: The damage and evidence of the track of the waterspout - the locations of A to F.

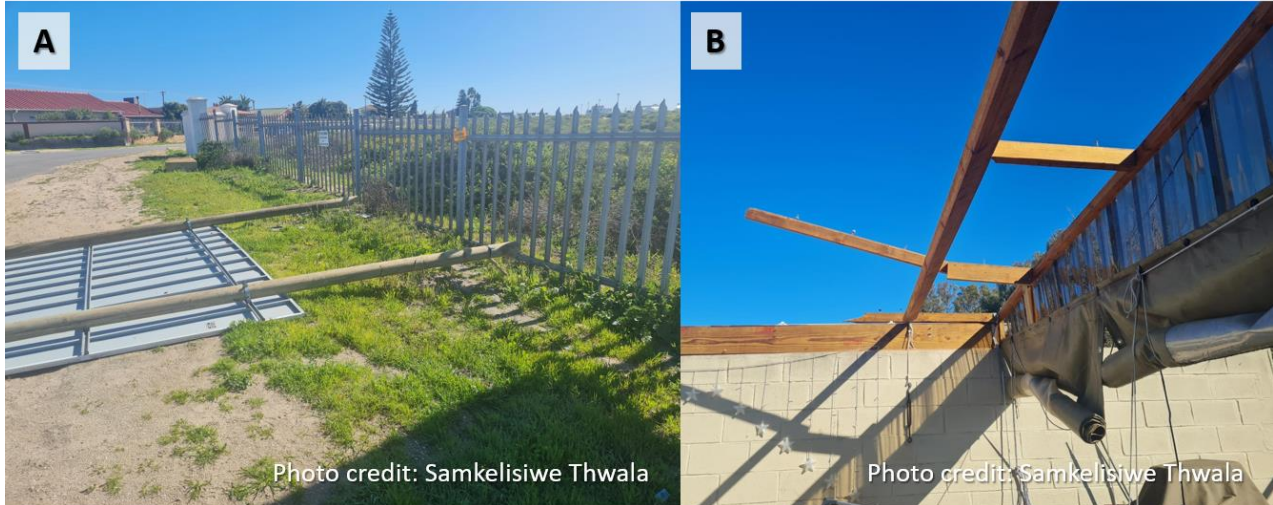
More evidence of the type of damage this waterspout caused can be seen in figure 4, which assisted with determining the Enhanced-Fujita (EF) rating (strength) of the waterspout. The traffic sign that was blown over by the force of the waterspout is located closer to the ocean (figure 4A), which supports the possibility that this waterspout had a longer track and duration. The severity of the roof damage of the second property can be seen in figure 4B.

Figure 4: A) Traffic sign blown over by the force of the waterspout; B) Roof damage after the roof sheeting was taken by the waterspout.

The South African Weather Service can confirm that an EF1 waterspout hit Velddrif during the afternoon of 13 August 2022. Any additional photos or videos of this event can be shared with the Cape Town Weather Office via email (factfc@weathersa.co.za) or via WhatsApp (084 279 1166).
