19 November 2020

### MULTICELL CLUSTER STORM CAUSES HAVOC IN MTHATHA ON 17 NOVEMBER 2020

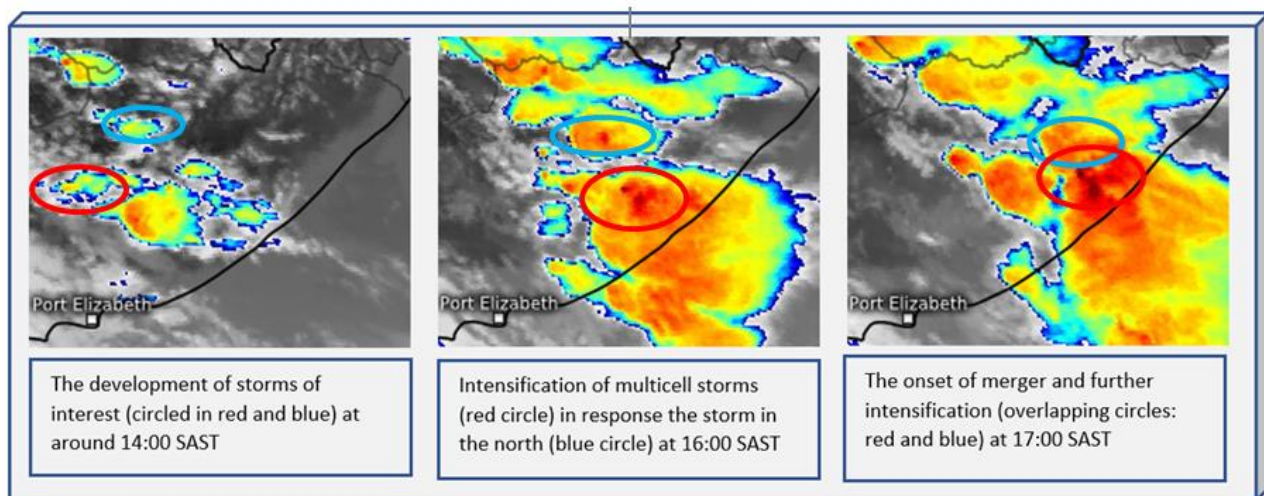
Figure 1: Gradual development of severe thunderstorms on the eastern areas of the Eastern Cape

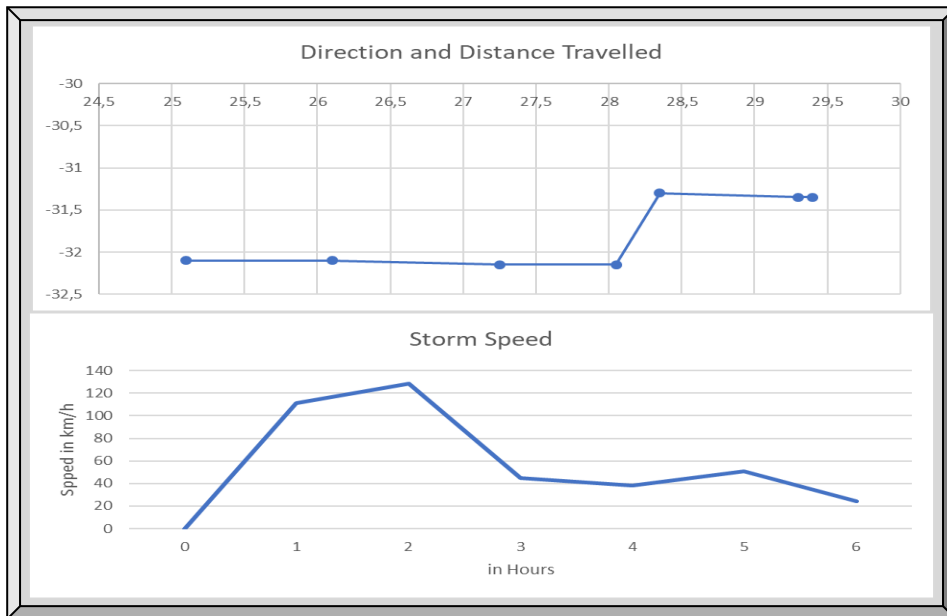
direction of movement, migrating towards the north-east, moving a further 68 km to Mbolompo (north-west of Mthatha) but at a significantly lower speed of about 33 km/h (compared to an earlier average of 94 km/h). Shortly after yet another change of storm movement, very high winds from the enhanced multicell storm resulted in damage to homes, vehicles and the nearby airport, while also uprooting trees and resulting in heavy downpours which led to localized flooding. The impacts as evidenced by the photographs and the short distance travelled between 17:00 and 18:00 SAST strongly suggest that there was an EF3 tornado.

Figure 2: Storm trajectory
