25 August 2023

Confirmation of EF-0 Landspout over Hanover Park on 25 August 2023

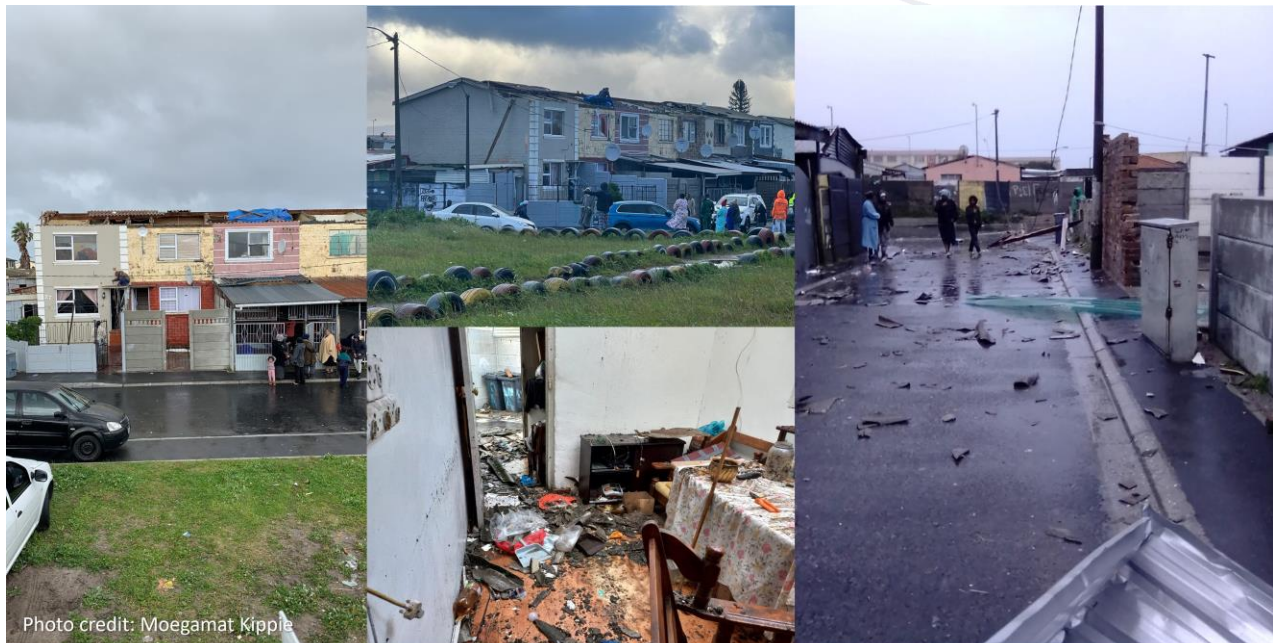
A well-developed cold front made landfall over the south-western parts of the Western Cape on Friday morning, 25 August 2023. This was the third cold front of a series of cold fronts that affected the Western Cape from the past weekend, which was dominated by cold, windy, and wet weather conditions. Hanover Park is situated in the Cape Flats, roughly 6,5 km south-west of the Cape Town International Airport (City of Cape Town District Municipality) in the Western Cape. After 07:00 SAST, a resident recalled seeing “a black twister like wind”. The main damage observed included roof tiles being blown off from an apartment building as seen in figure 1.

Figure 1: The damage due to the EF-0 landspout that hit Hanover Park on Friday morning, 25 August 2023.
